**Road and Landslide Sediment Source Investigation
And Sediment Reduction Plan
For the Scotts Creek Watershed
Santa Cruz County, California**

**The Scotts Creek Watershed Council
Davenport, California**

March, 2000

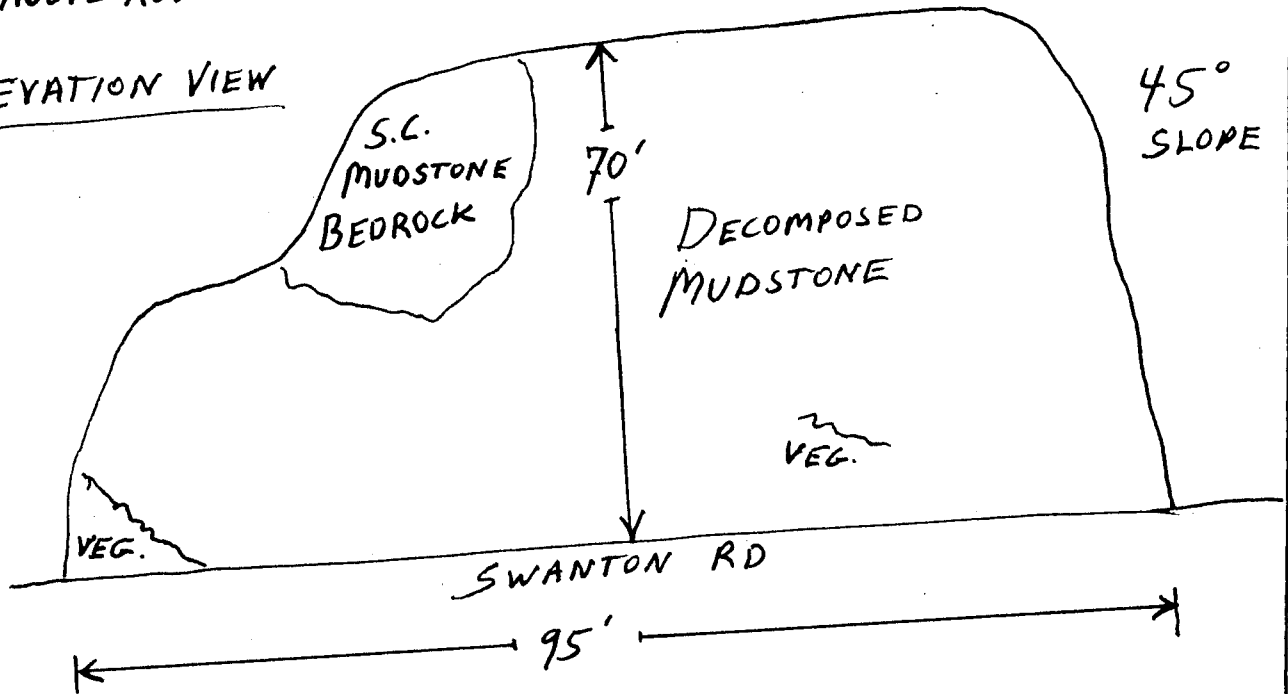
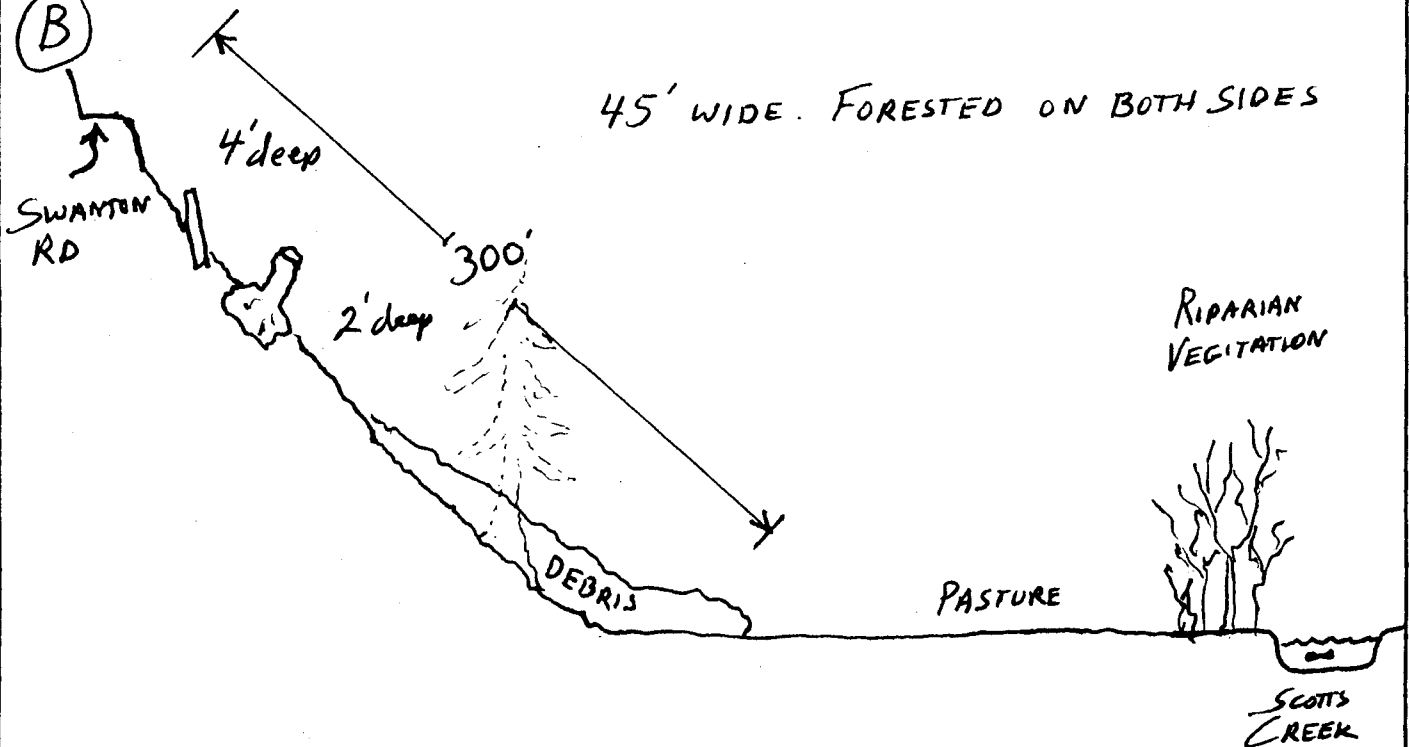
SLIDE DIAGRAM

(A) ABOVE ROAD

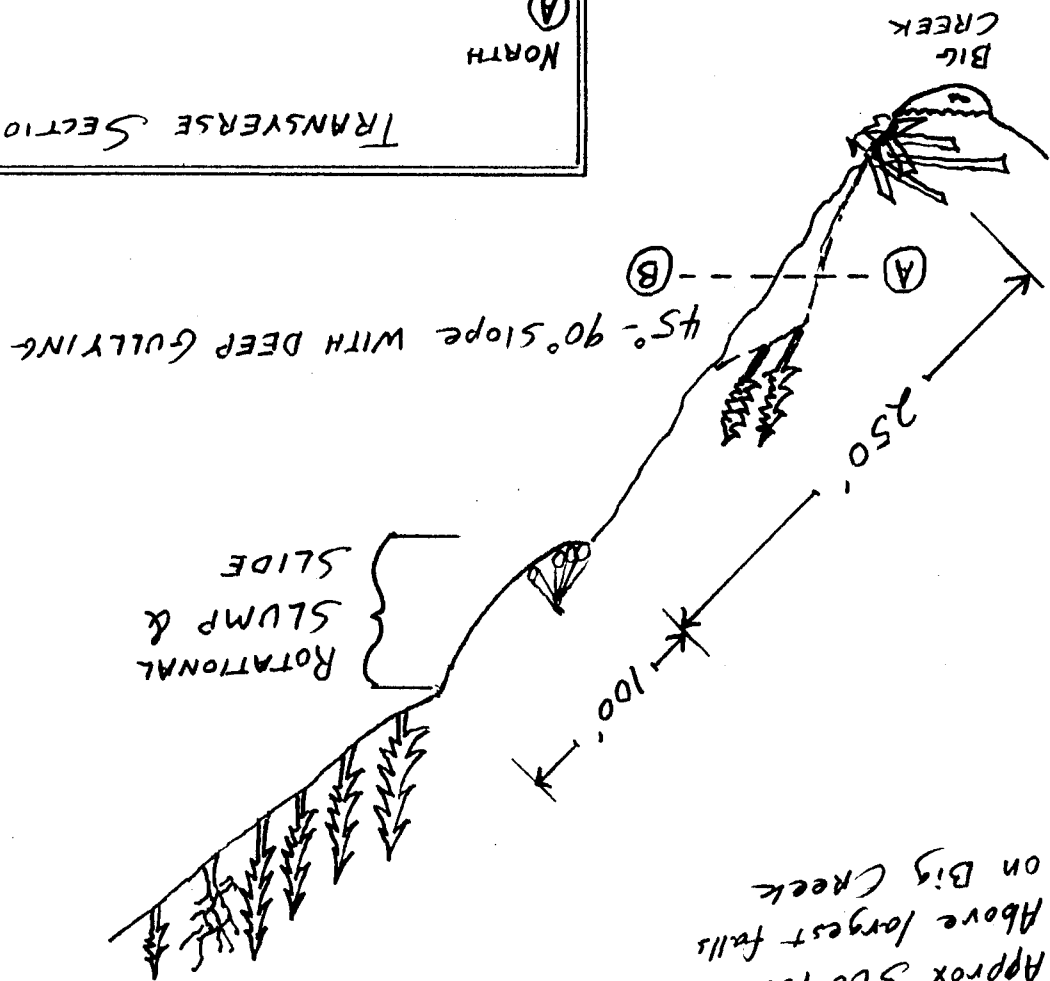
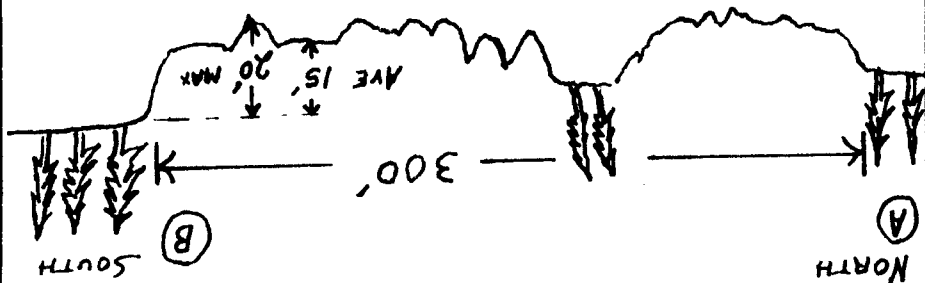
SLIDE DIAGRAM

SITE LOCATION:
 N 37° 05' 14" (3)
 W 122° 12' 85" (5)
 Approx 500 yards
 Above largest falls
 on Big Creek
